Glacial Lakes and Glacial Lake Outburst Floods in Nepal

This assessment of glacial lakes and glacial lake outburst flood (GLOF) risk in Nepal was conducted with the aim of developing recommendations for adaptation to, and mitigation of, GLOF hazards (potentially dangerous glacial lakes) in Nepal, and contributing to developing an overall strategy to address risks from GLOFs in the future. The assessment is also intended to provide information about GLOF risk assessment methodology for use in GLOF risk management in Nepal. The methodology that was developed and applied in the assessment can also be broadly applied throughout the Hindu Kush-Himalayan region. The assessment has been completed through activities carried out in collaboration with national partners, which include government and non-government institutions as well as academic institutions and universities.

This report was prepared by the International Centre for Integrated Mountain Development (ICIMOD) for the Global Facility for Disaster Reduction and Recovery (GFDRR)/The World Bank.

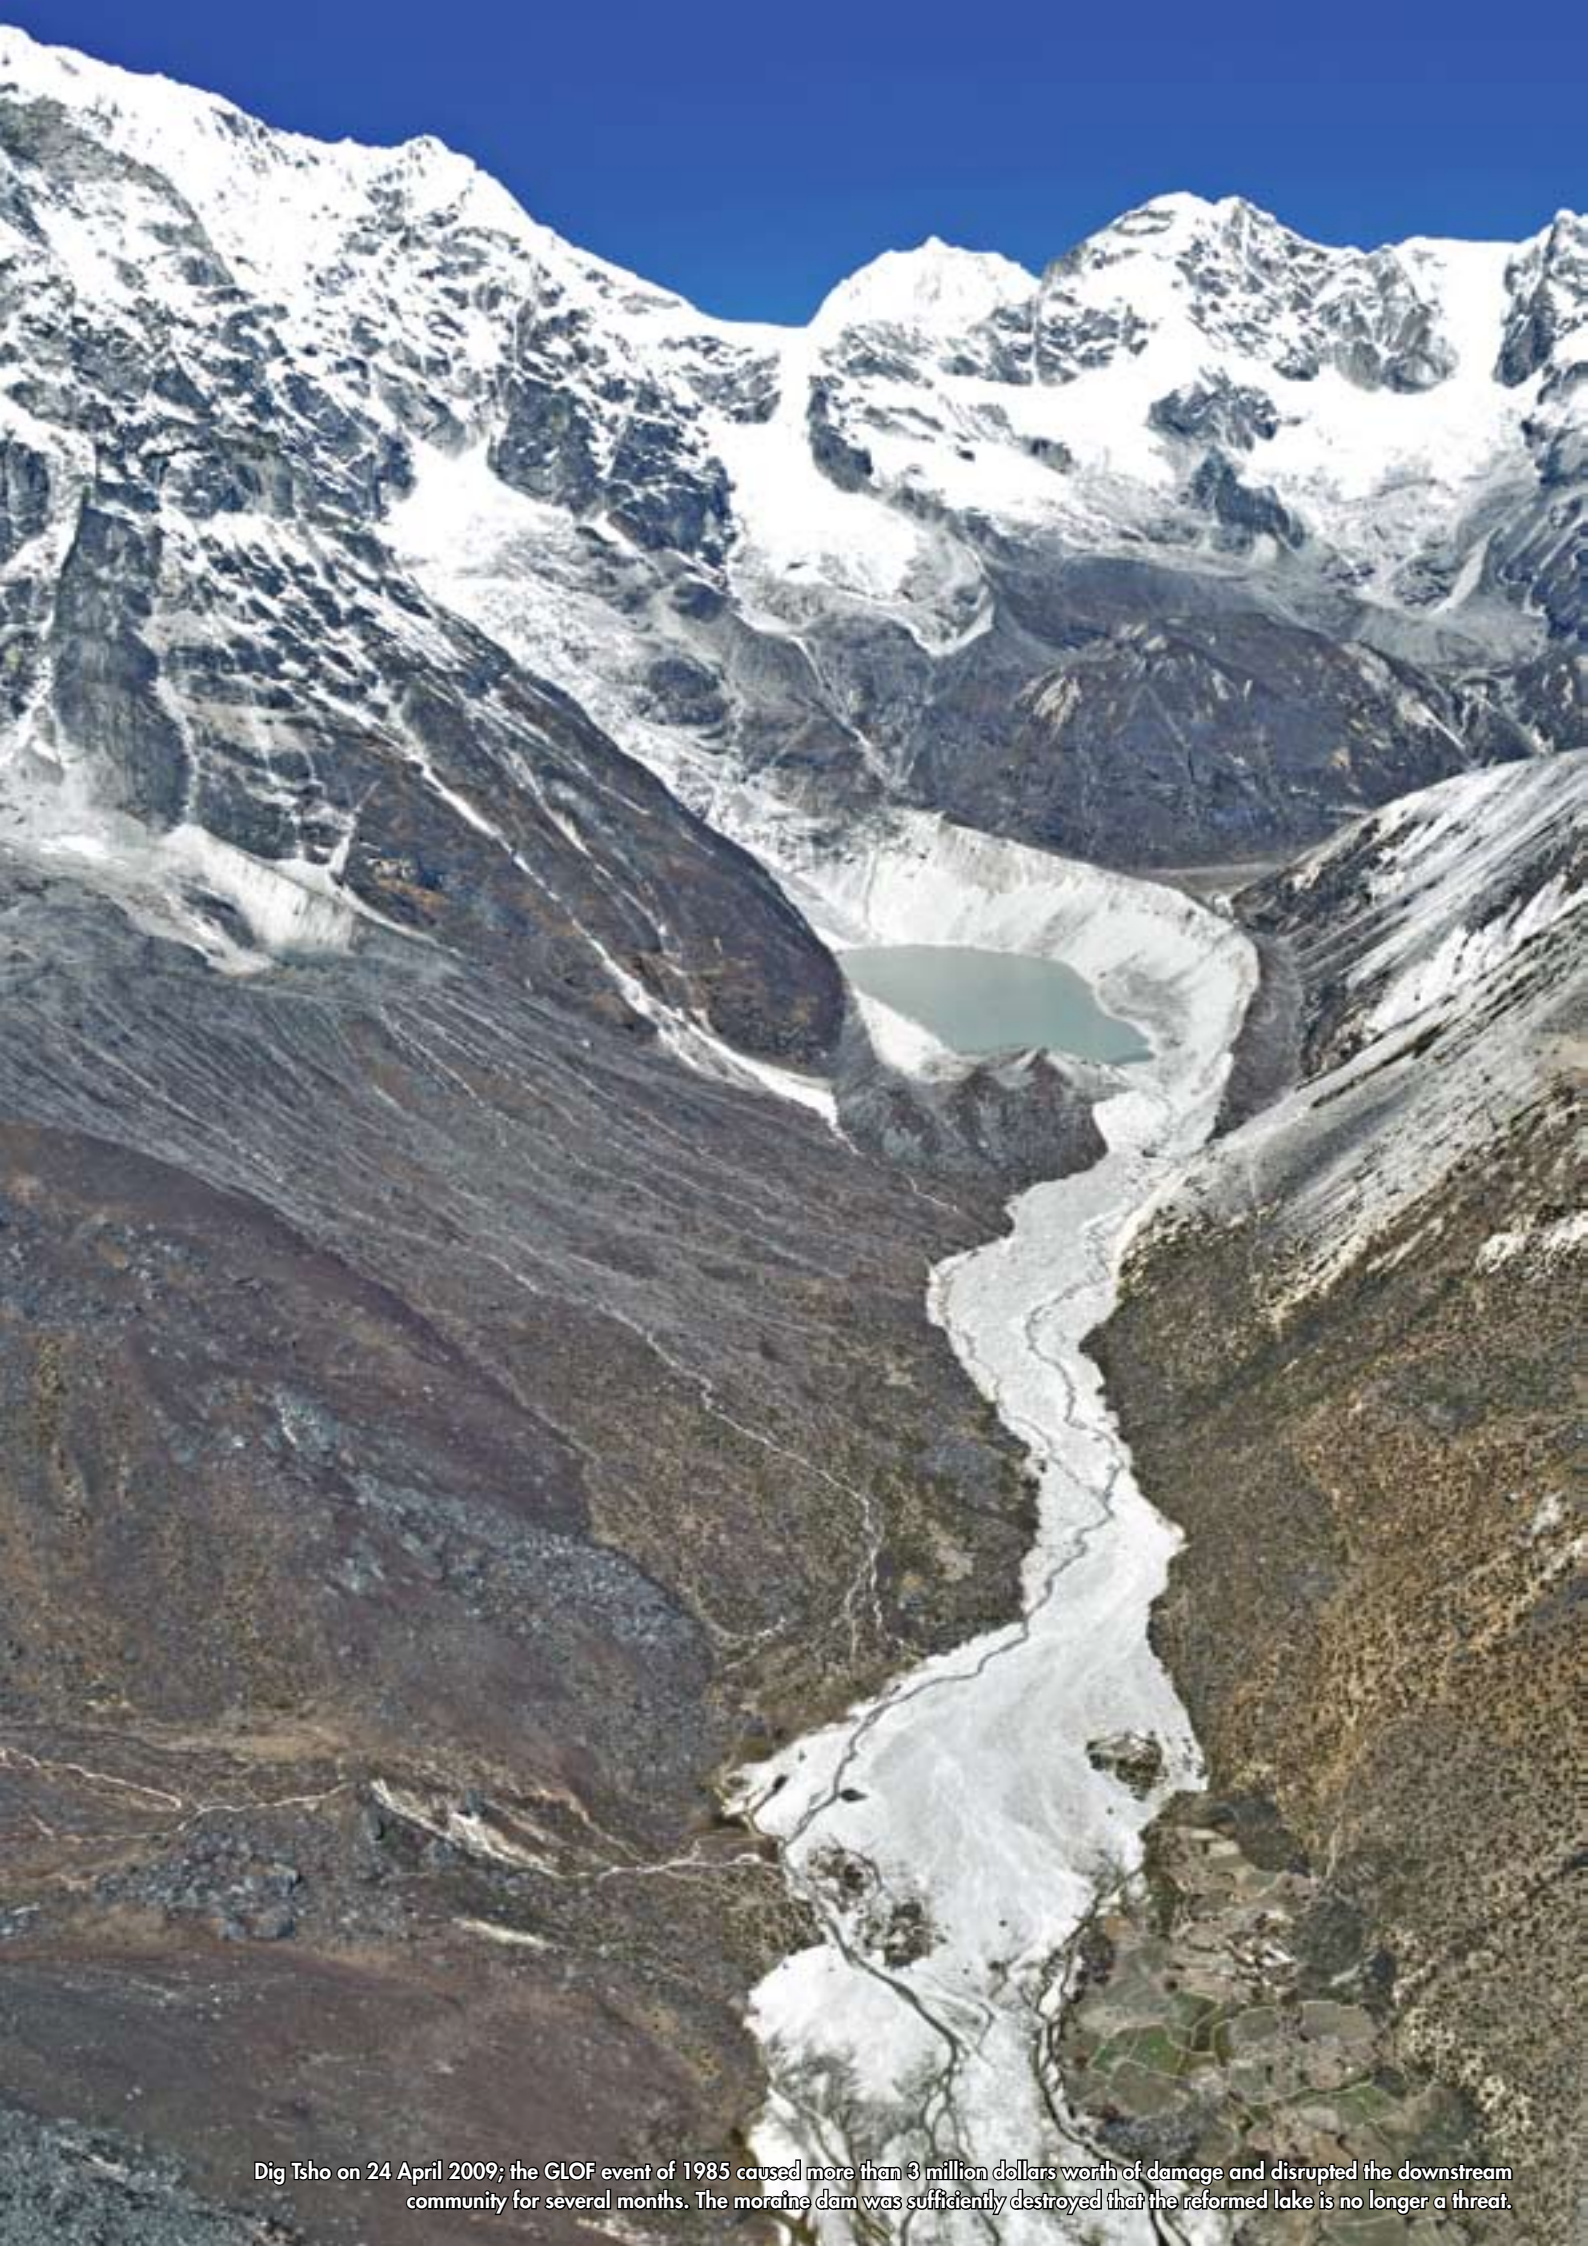
Dig Tsho on 24 April 2009; the GLOF event of 1985 caused more than 3 million dollars worth of damage and disrupted the downstream community for several months. The moraine dam was sufficiently destroyed that the reformed lake is no longer a threat.

When the end moraine dam of the Dig Tsho collapsed, the water from the lake drained into the valley downstream over a four-hour period, wreaking destruction as it went. This sudden outburst destroyed the nearly completed Namche Small Hydel facility, some 11 km downstream and caused other losses as far as 50 to 60 km downstream. Somewhat ironically, Dig Tsho was not typical of the large glacial lakes that have formed supra-glacially, but was one of the smaller 'clean-ice' glacial lakes. The outburst event was triggered by a large ice and rock avalanche that cascaded into the lake from a steep glacial surface: when it splashed into the lake it produced a surge wave. The surge overtopped the end moraine and caused it to collapse, discharging an estimated 6 - 10 million cubic metres of water into the valley below. The outbreak of Dig Tsho caused more than three million dollars worth of damage and disrupted the downstream community of Khumbu for several months. The alarm bells sounded by this outburst event put in motion a plethora of scientific investigations, including, surveys, research, and preliminary estimates of downstream vulnerability among others. The Water and Energy Commission Secretariat (WECS) of the Nepal Government, the International Centre for Integrated Mountain Development (ICIMOD), and the United Nations University (UNU) collaborated in the work that eventually produced the first detailed assessment of a GLOF event in Nepal (WECS internal report 1987; Ives 1986; Vuichard and Zimmermann 1986, 1987).

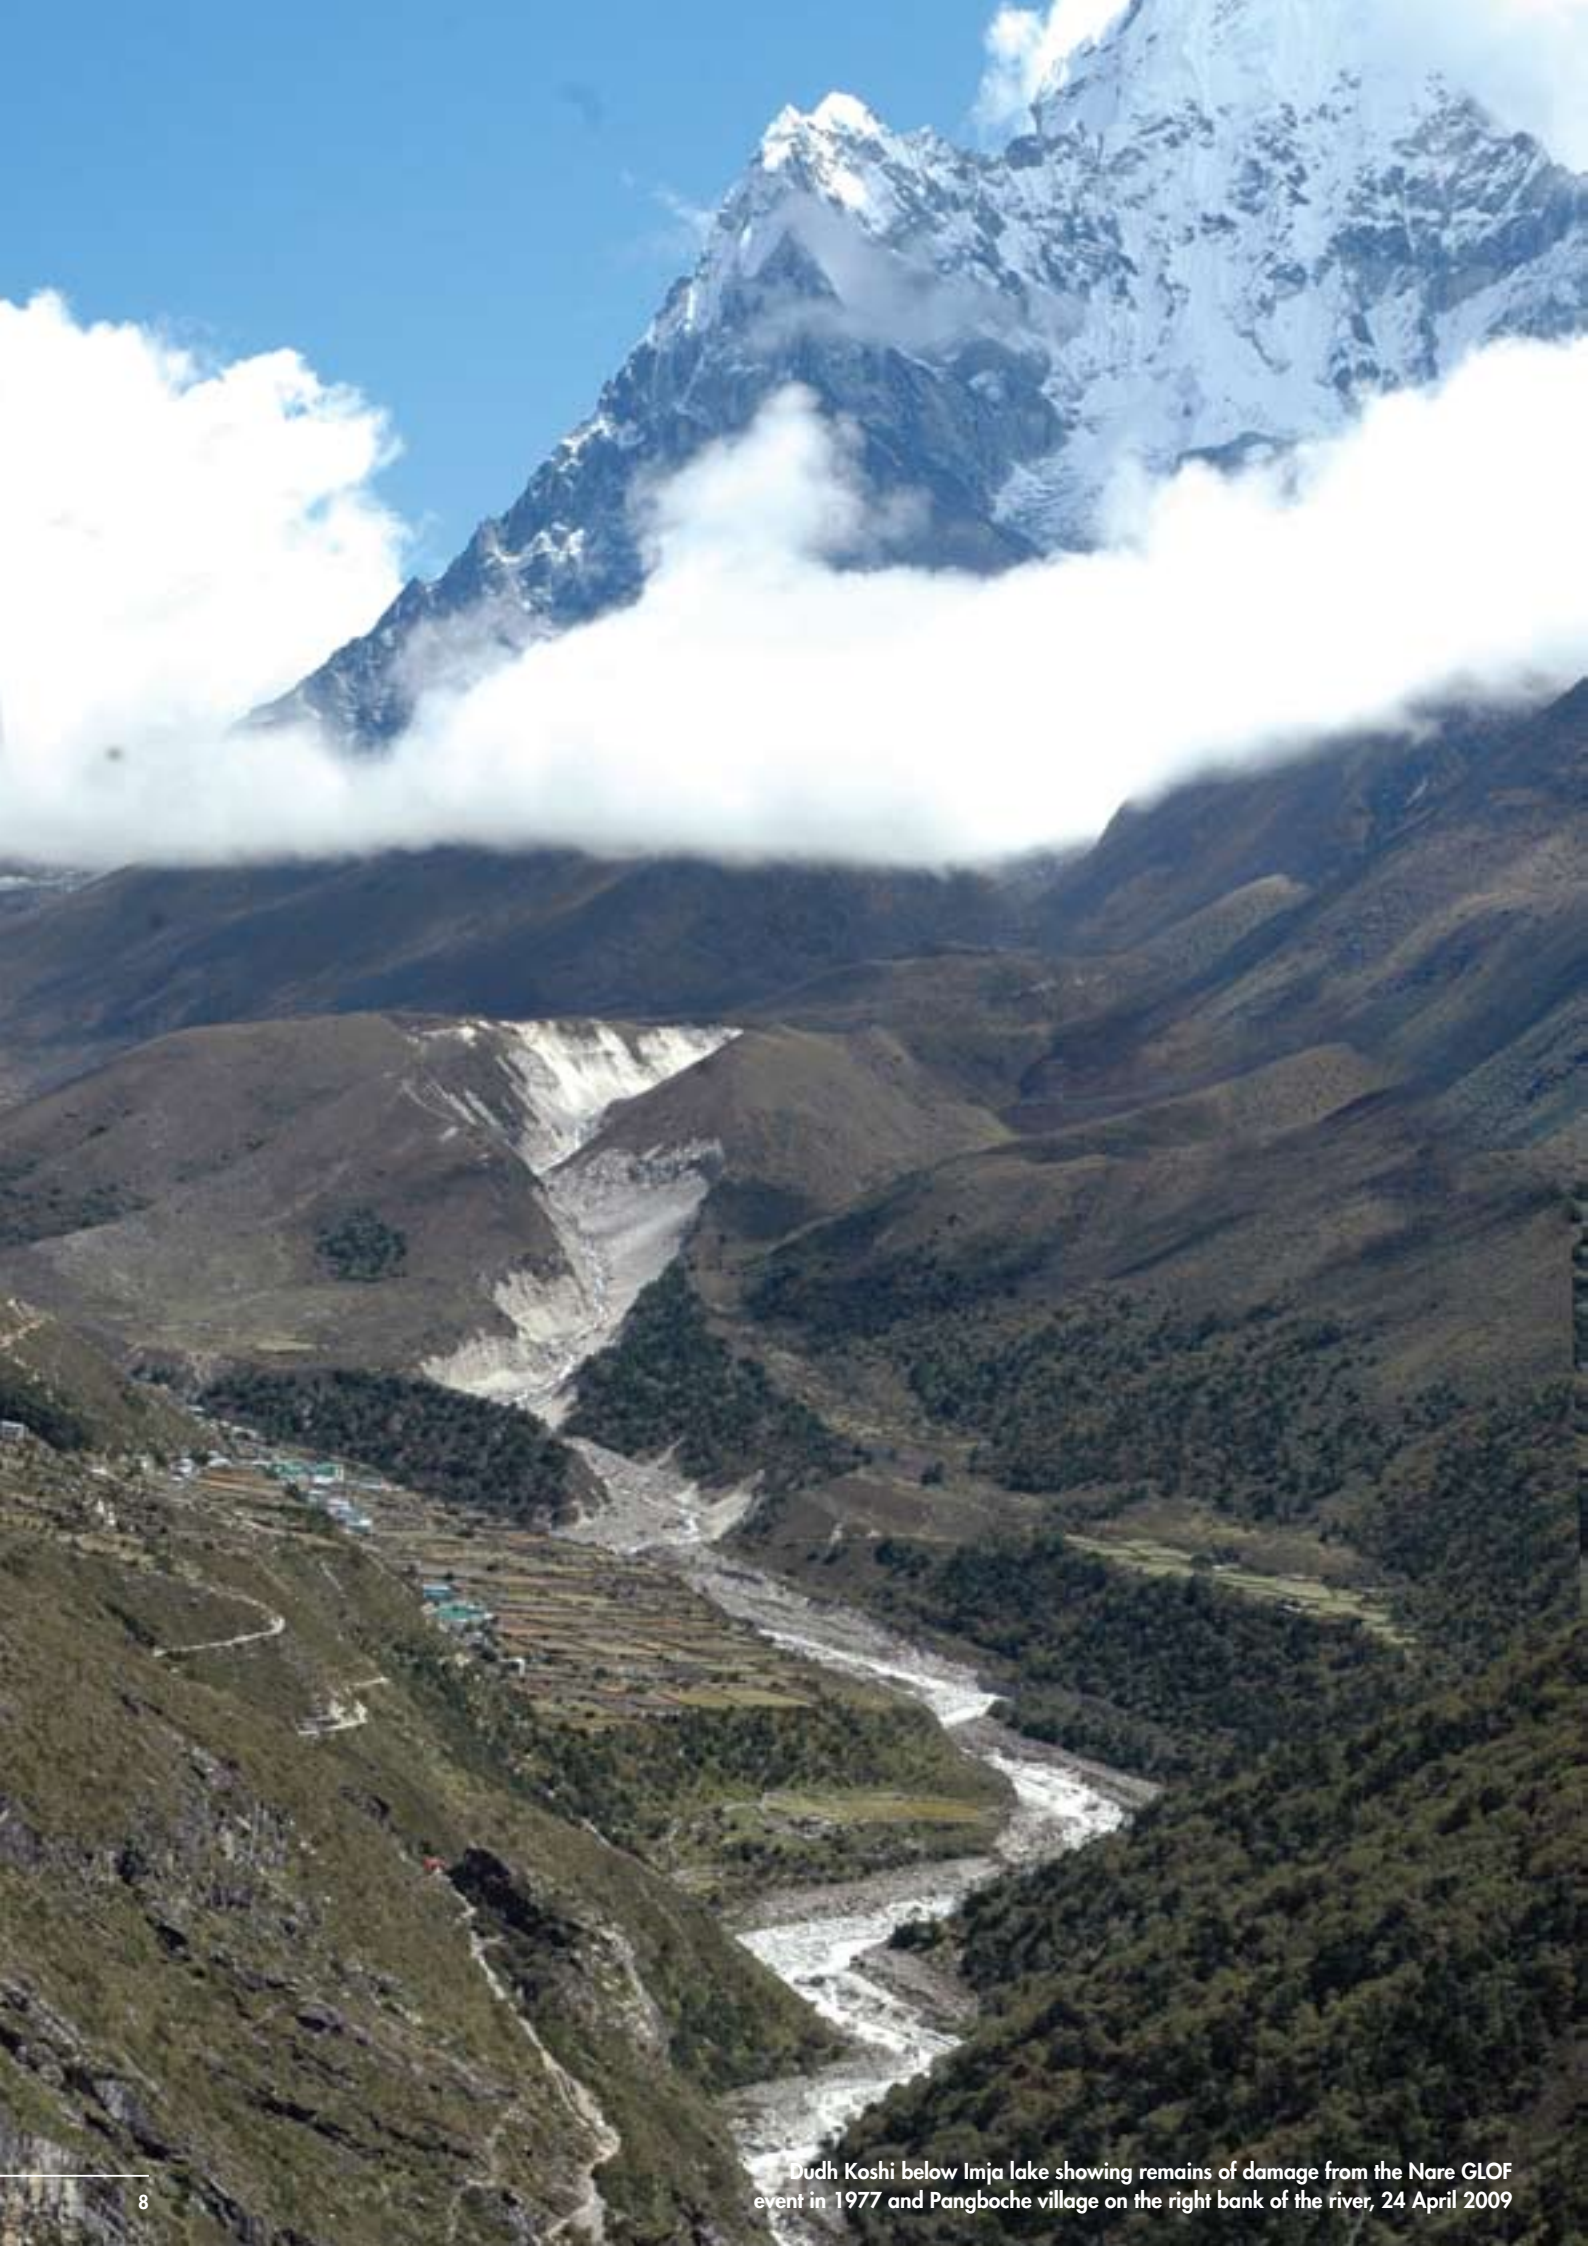
Dudh Koshi below Imja lake showing remains of damage from the Nare GLOF event in 1977 and Pangboche village on the right bank of the river, 24 April 2009

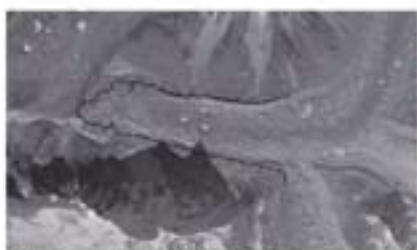
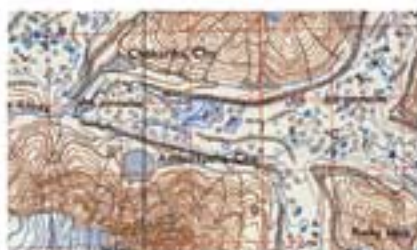
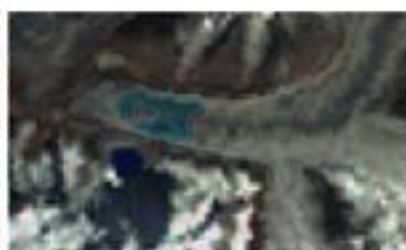
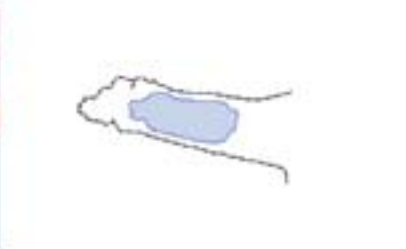
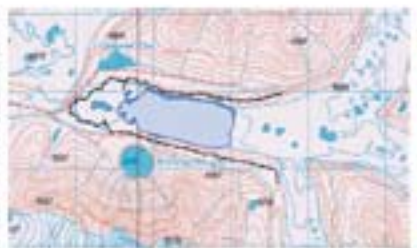
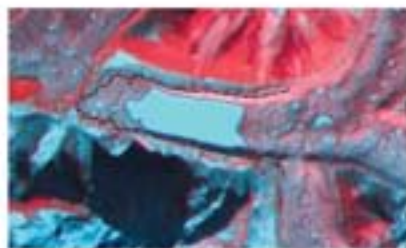
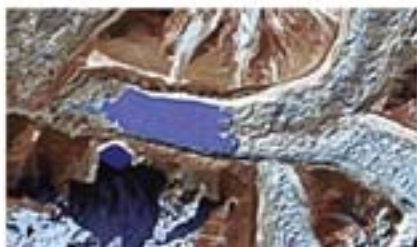
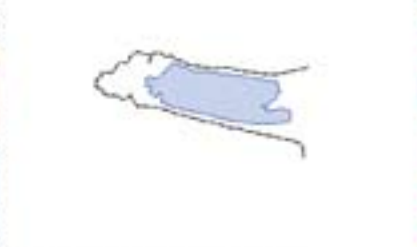
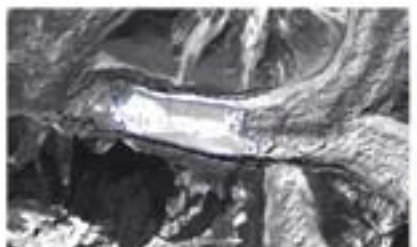
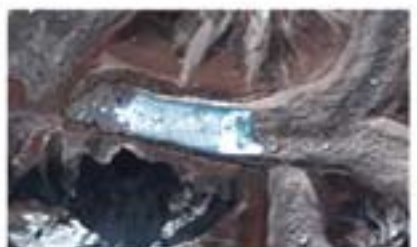
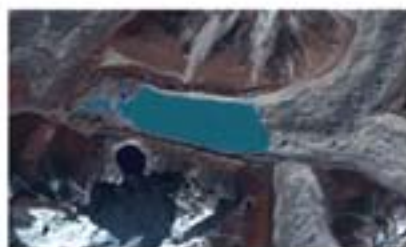
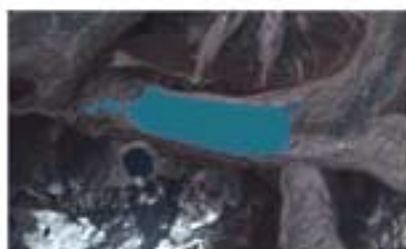
Figure 7.3 shows the progressive development of Imja Tsho between 1962 and 2010.

Figure 7.3: Development of Imja Tsho from 1962 to 2010 based on Corona (1962) images, Topographical Map (1967), Landsat MSS (Oct 1975), Landsat TM (April 1984, Dec 1989), Aerial photo (1992), LISS 3 (Jan 1999), Landsat ETM+ (Oct 2001, Nov 2005), ALOS PRISM (2006), AVNIR-2 (Nov 2007, Nov 2008, and Mar 2009), Field Survey (WECS 1992, DHM 1997, GEN 2002 and ICIMOD 2009), and EO1_ALI (USGS) Oct 2010)

In 1992 the lake area was 0.60 sq.km and its volume 28×10^6 cu.m (Yamada 1992). The field investigations showed that by 2009 the lake area had increased to 1.01 sq.km and the storage capacity to 35.5×10^6 cu.m; the maximum depth obtained was 96.5 m. The bathymetric and topographic maps from the field survey are shown in Figure 7.4. The lake area continues to increase, but with a reduction in the rate of growth since 2001. At the same time, the actual level of the lake fell by 0.3 to 0.4 m/yr between 2001 and 2009, while benchmarks towards the end moraine subsided by about 0.1 m/yr (GEN 2006 and ICIMOD Field Survey 2009). The level differences between the benchmarks on the lateral moraines are becoming less, although not uniformly, indicating irregular settling of the surface of the moraine dam over the last seven to eight years.

The contemporary expansion of Imja Tsho is primarily towards the east as the relatively warm lake water melts back into the glacier and accentuates the collapse of blocks of ice from the cliffs that form its terminus. (Yamada 1992; DHM 2001a; Sakai et al. 2005; GEN 2006; and present study). The western margin of the lake close to the end moraine has also expanded, although the position of the outlet has remained more or less unchanged. Watanabe et al. (1994) reported a rapid westward expansion towards the end moraine between 1989 and 1994. Shifting of the outlet channel was also reported (Watanabe 2009). This is not supported by Yamada (1992) nor by the present field investigation, and no significant change between 1992 and 2009 can be detected from the satellite images (Figure 7.4).

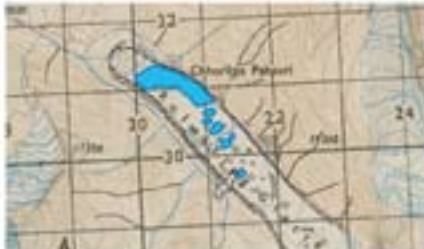
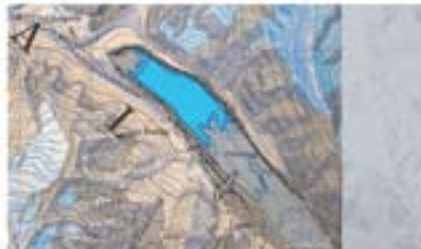
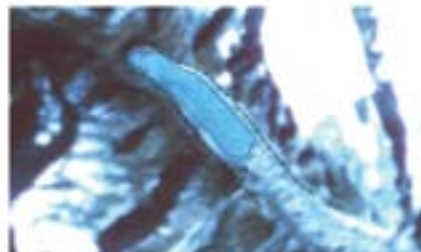
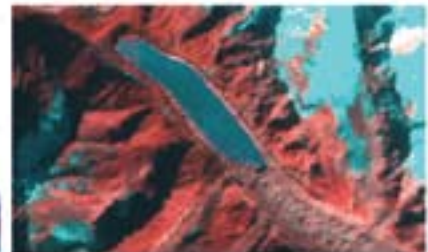
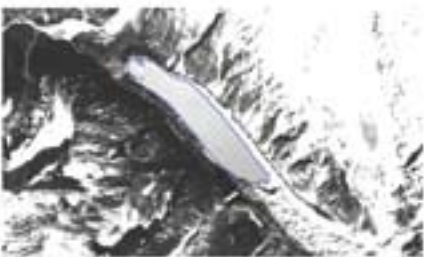
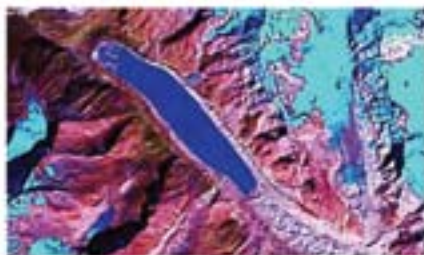
Figure 7.7: Development of Tsho Rolpa from 1957 to 2009 based on Topography Map (1957-59), Schneider Map (1960-68), Corona (1973), Landsat MSS (1975), Spacelab IR (1983), Landsat TM (1991), Aerial Photo (1992), LISS-3 (1999), Landsat ETM+ (2000), AVNIR-2 (2007), WECS Field Survey (1993-94) and ICIMOD (2009)

Development of Tsho Rolpa is shown in Figure 7.7. During the late 1950s, Tsho Rolpa existed only as a group of six small supra-glacial ponds. Between 1957 and 1959 its area was about 0.23 sq.km. The lake grew continuously from the beginning of the 1960s and by the 1990s it had enlarged to such an extent that it was considered to be on the verge of breaching its end moraine. Satellite images (MOS1 MESSR) showed that it had grown to 1.27 sq.km by 1990 and 1.55 sq.km by 1999. Mitigation work was completed in 2000; this included construction of a gated outlet channel that

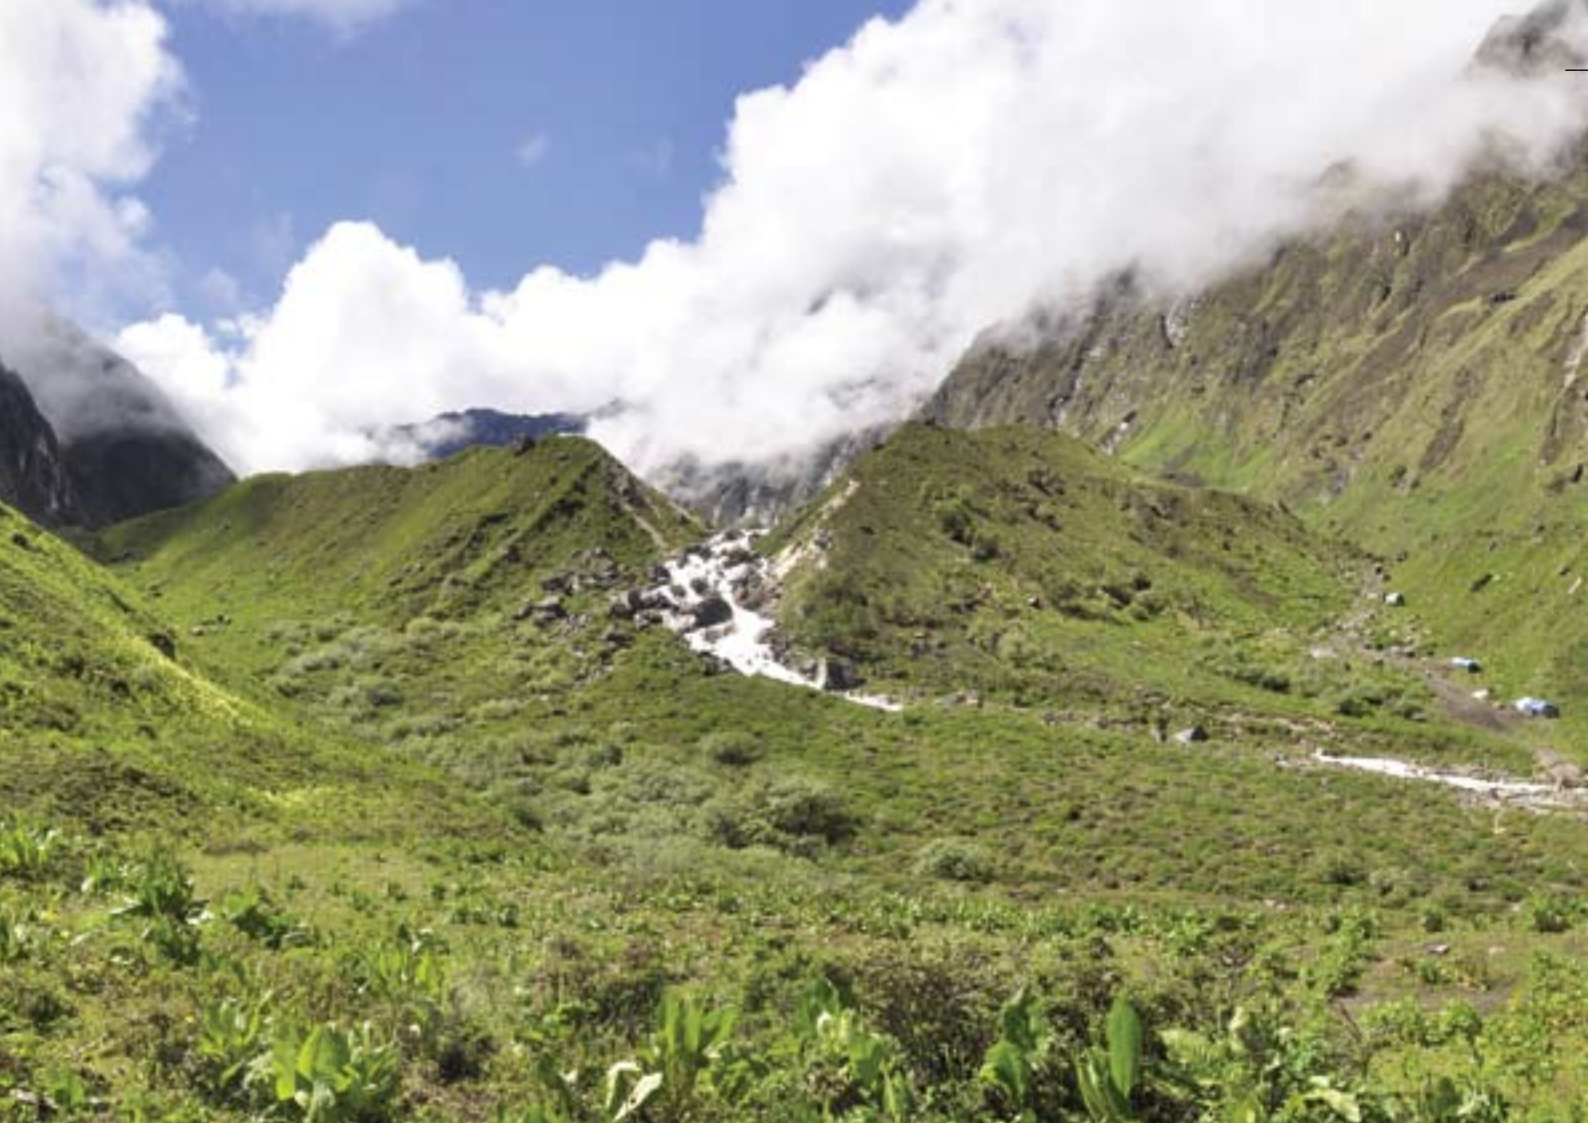
Figure 7.15: The steep Thulagi outlet flowing through a narrow valley, 17 July 2009

There are no long-term meteorological data available for Thulagi Lake. The nearest meteorological station is located at Dharapani some 2000 m below Thulagi and thus represents quite different climatic conditions. The catchment area of the lake is approximately 56 sq.km of which 55% is covered by ice. It is mainly fed by meltwater from the Thulagi Glacier as well as by other cross-drainage systems. The outlet has a well-developed channel and appears to be stable (Figure 7.15).

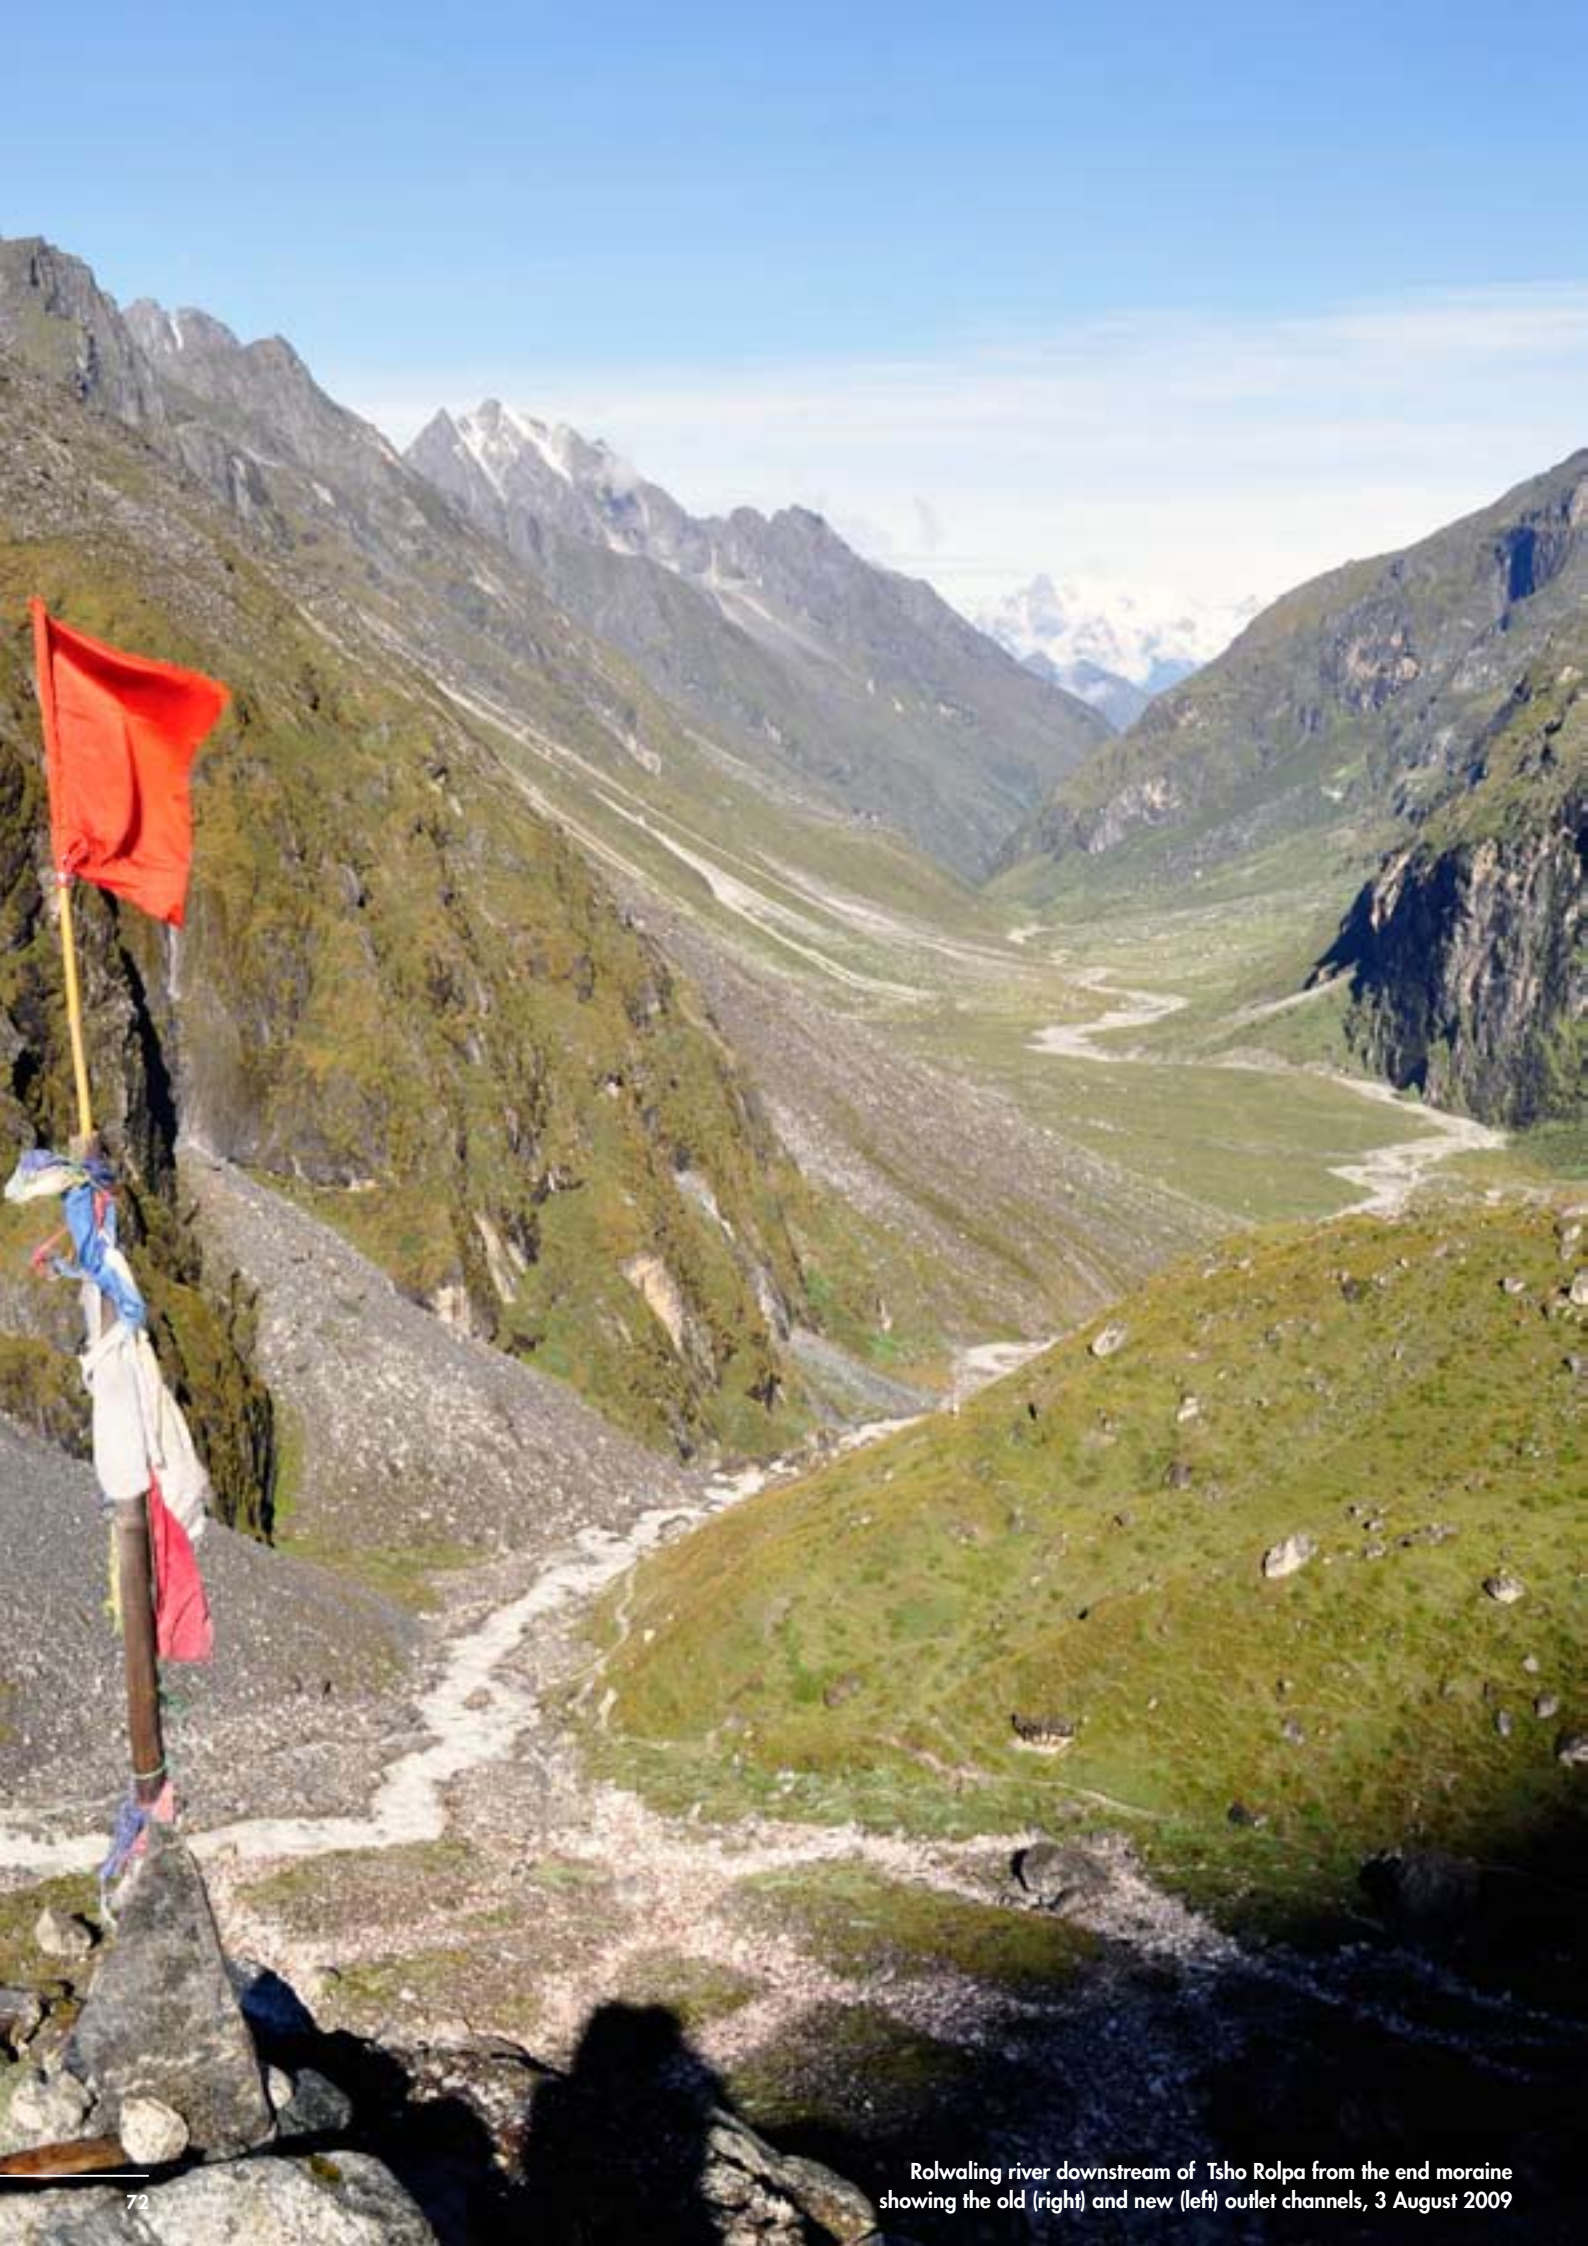
Rolwaling river downstream of Tsho Rolpa from the end moraine showing the old (right) and new (left) outlet channels, 3 August 2009
